Urgent Field Safety Notice

SynchroMed® II Implantable Infusion Pump Design Enhancements Models 8637-20, 8637-40 Device Retrieval

1 March 2016

Medtronic reference: FA696

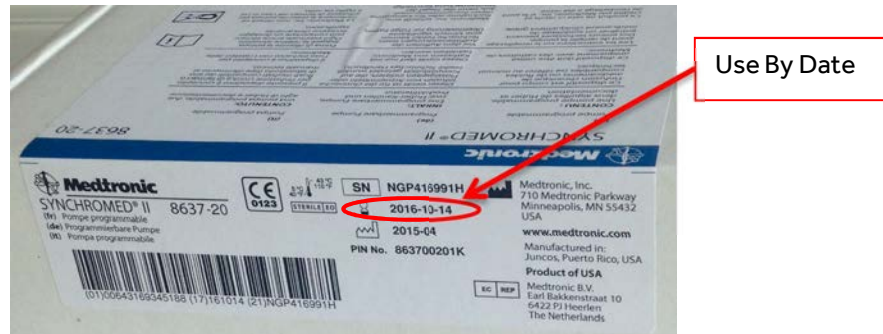
SynchroMed II -- Shelf Box Side Label

Any pump with a Use By date **on or before** 14/May/2017 was manufactured **prior to** design changes.

This letter is to inform you that your Medtronic Representative will review your inventory and retrieve any unused SynchroMed II pumps that were manufactured prior to the design changes mentioned above. For your information, SynchroMed II pumps manufactured prior to the design changes can be identified based on Use By date as shown below:
