**URGENT UPDATE: Field Safety Notice**

**FSCA identifier:** Product Field Action RA2013-083  
**Type of Action:** Field Safety Corrective Action  
**Description:** Triathlon Tibial Alignment Ankle Clamp EM (Instrument)  
**Catalog #:** 6541-2-609  
**Lot #:** All

## Product Correction Bulletin

Triathlon Tibial Alignment Ankle Clamp

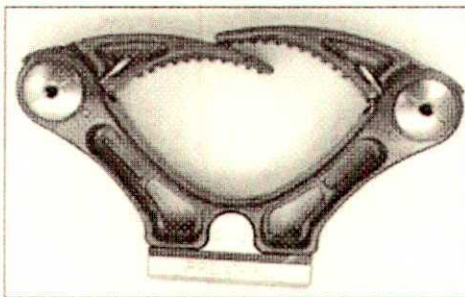
Figure 1  
Predicate Design  
Triathlon Ankle Clamp (6541-2-609) Revision G

Please note that we have begun the planned transition of RA2013-083 from a Product Correction (see June 2013 Bulletin – lit. ref. TRIATH-BU-3) to a Product Recall. In this second phase of the Action, which will extend into 2015, we will replace all plastic (Rev. G) ankle clamps with metal (Rev. H) clamps. Images of both clamps are provided below for reference.

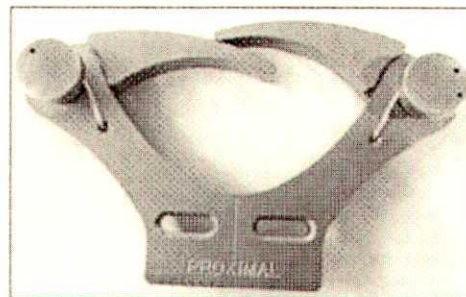
Figure 2  
New Design  
Triathlon Ankle Clamp (6541-2-609) Revision H

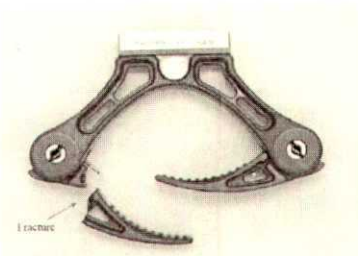
Figure 1

Stryker Orthopaedics has received complaints associated with cracks or fracture of the Triathlon Tibial Alignment Ankle Clamp.

In the event of a fracture of the ankle clamp portion of the tibial alignment assembly at the flipper (figure 1) or at the yolk (figure 2), the instrument will still function as intended.

The process will remain the same as defined in the surgical protocol (ref. LSPK47 Rev5). Assemble the Tibial Alignment Ankle Clamp to the Tibial Alignment Distal Assembly EM. In case of a compromised Ankle Clamp, firmly hold the Tibial Alignment Distal Assembly EM and press up to/against the Tibia while maintaining alignment. In accordance with the Triathlon Surgical Protocol, flexion / extension alignment is correct when the long axis of the Tibial Resection Assembly parallels the mid-coronal plane of the tibia. Varus / Valgus alignment is similarly assessed per the established methods. (figure 3)
