Urgent Field Safety Notice

Claria MRI™ CRT-D SureScan™ and Amplia MRI™ CRT-D SureScan™

12 December 2016

Medtronic reference: FA747

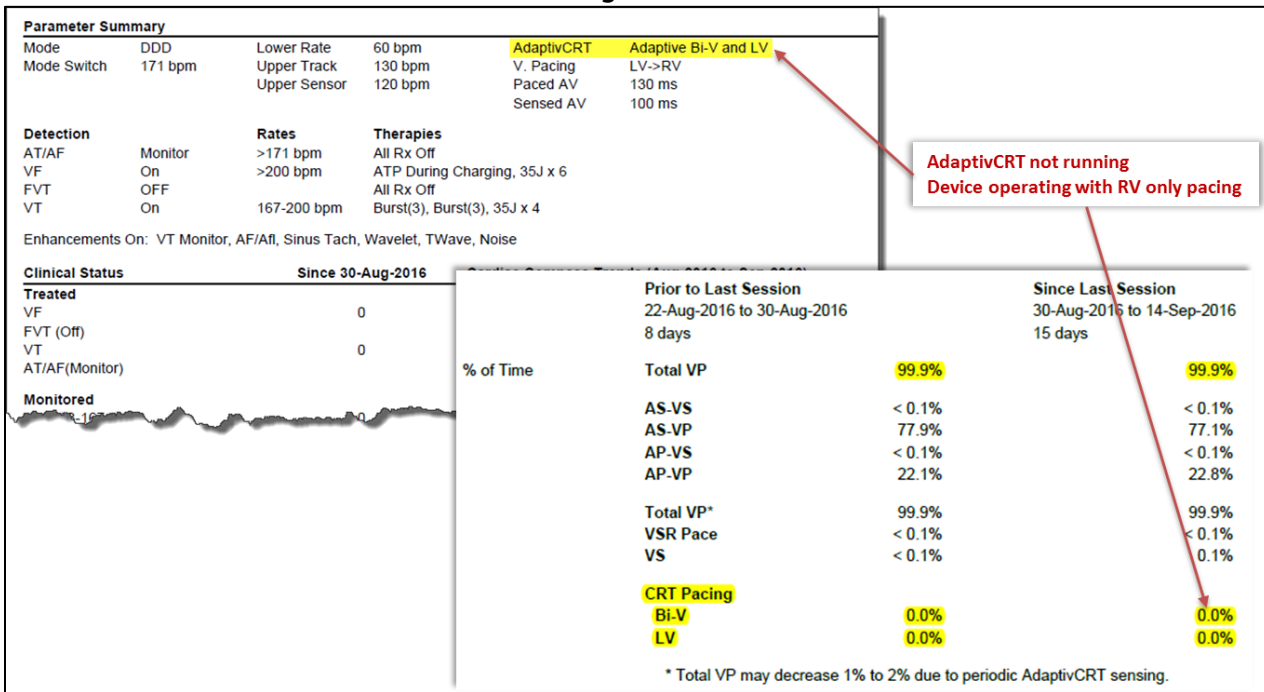
Figure 1

When a patient with AdaptivCRT enabled (shipped setting) is subsequently programmed to MVP mode and then re-programmed back to DDD or DDDR, AdaptivCRT is not re-enabled. When this programming sequence occurs, LV pacing is not delivered, despite parameters indicating AdaptivCRT is enabled (Appendix B, Figure 1). This will result in RV only pacing which may be undesirable for the patient. LV pacing will remain disabled until a specific programming sequence is manually completed; refer to the Patient Management section of this letter (Appendix B) for details.

- If the CRT setting is currently programmed to *Adaptive Bi-V and LV* or *Adaptive Bi-V* (Figure 1), review rate histogram CRT Pacing percentages (CRT Pacing: Bi-V and LV).
- If Bi-V and LV pacing percentages *Since Last Session* are both near 0%, then the device has encountered the programming sequence and has lost LV pacing; proceed to step 2.

- Select the CRT parameter window, select *Nonadaptive CRT*, and select *PROGRAM*.
- Select the CRT parameter window, select the desired AdaptivCRT setting (*Adaptive Bi-V and LV* or *Adaptive Bi-V*), and select *PROGRAM*.
