### **URGENT FIELD SAFETY NOTICE**

Product Name: **Alaris VP Plus with Guardrails**  
Product codes: **9003MED01-G and 9003TIG01-G**  
FSCA Identifier: **RA-2016-10-02**  
Date: **November 2016**  
Type of Action: **Advisory Notice**

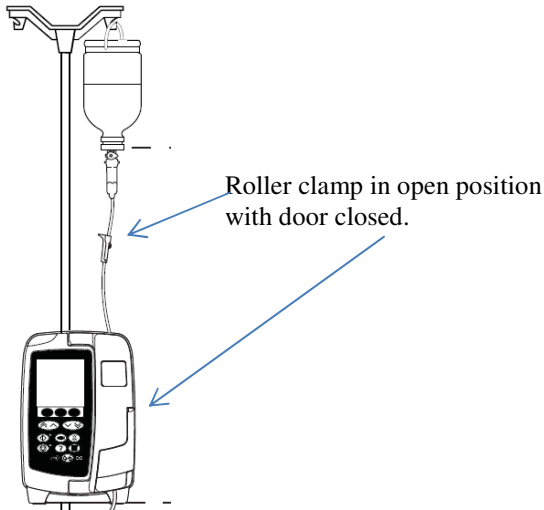
CareFusion has identified a potential risk with the Alaris VP LVP that results in a situation where the upstream occlusion alarm does not generate within the prescribed time period.

1. The Alaris™ VP *plus* Guardrails™ Directions for Use state that upon completion of loading the tubing into the pumping chamber, the user should close the door and open the roller clamp.

Opening the roller clamp once the door is closed will eliminate the potential for an upstream occlusion.
