## Urgent Field Safety Notice

**Commercial name/Model:** *BeneFusion VP1, BeneFusion VP3 infusion pump*

**FSCA-identifier:** *JXXY-20170717*

**Type of action:** *Safety Notice and Device modification*

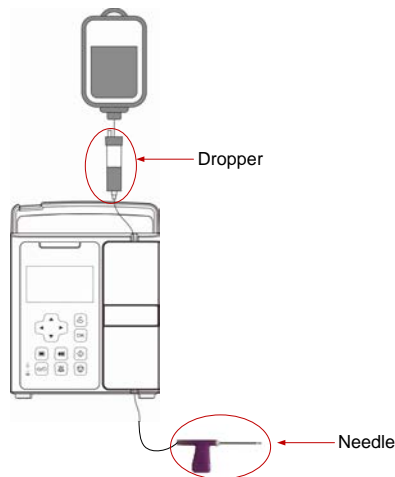
**Rate Abnormality Screening Method**

- 4). Observe the dropper or needle for 30 seconds:
    - a) If any drop drips or increases gradually, then the flow rate is abnormal, pump should be removed from clinical use and quarantined.

- b) If NO drop drips or increases gradually was observed, then the infusion pump could be used normally for this infusion.
