**Draft: Recall Letter / Field Safety Notice**

**FSCA identifier:** Product Field Action PFA\_1458567\_2017-039

**Type of Action:** Field Safety Corrective Action: Recall

**Legal Manufacturer:** Stryker GmbH, Bohnackerweg 1, 2545 Selzach, Switzerland

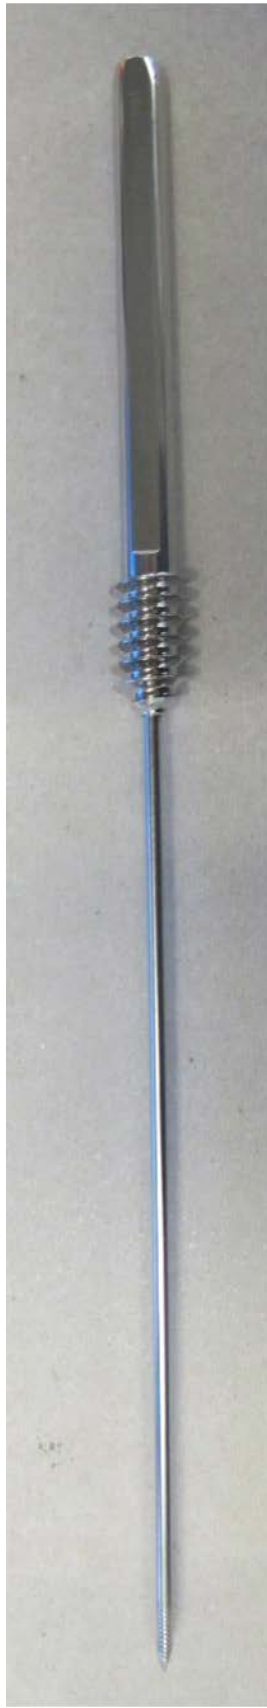
Stryker received a complaint from the field regarding a Standard Lag Screw Omega 110mm LENGTH (Cat# 33625110 & Lot# V06279). The end customer reported via sales rep, that the lag screw was not completely cannulated and the guide wire could not go through the cannula of the screw. No harm reported.

The Investigation revealed that the obstruction is related to a metal burr in the cannula of the screw which was not removed during manufacturing. The nonconformance is limited to 2 batches.

**Figure 1: Affected screw with guide wire.**

Recall of subject devices.

1. Immediately check your internal inventory and quarantine all subject devices pending to return to Stryker.
2. Circulate this Field Safety Notice internally to all interested/affected parties.
