الموضوع: إشعار بمتابعة جهاز طبي مغروس

Osteosynthesis, bone plates. Oasys midline occiput plate.

URGENT FIELD SAFETY NOTICE: RA2013-033

Product Description: OASYS MIDLINE PLATES
Reference No.: 4855104(4)-(8) & 4857104(4)-(8)

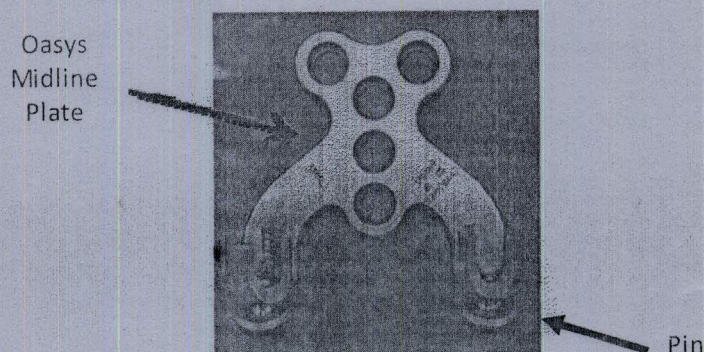
Customer reports for revision surgeries due to pin breakage have exceeded pre market identified thresholds. The pin connects the tulip head to the Midline Plate.

An internal investigation has been initiated to determine the root cause for discrepancy and to ensure that appropriate corrective actions are put into effect. Pending the results of this investigation a removal action is taken as a precautionary measure in order to preserve patient safety.

1. Immediately check your internal inventory and quarantine all subject devices pending return to Stryker
2. Circulate this Field Safety Notice internally to all interested/affected parties.
