## Urgent Field Safety Notice

### Adapta™, Versa™, Sensia™, Relia™, Attesta™, Sphera™, and Vitatron™ A, E, G, Q Pacemakers Software Update

Medtronic reference: FA857 Phase II

## Urgent Field Safety Notice For a Subset of Medtronic Dual Chamber Pacemakers Recall and Patient Management Recommendations

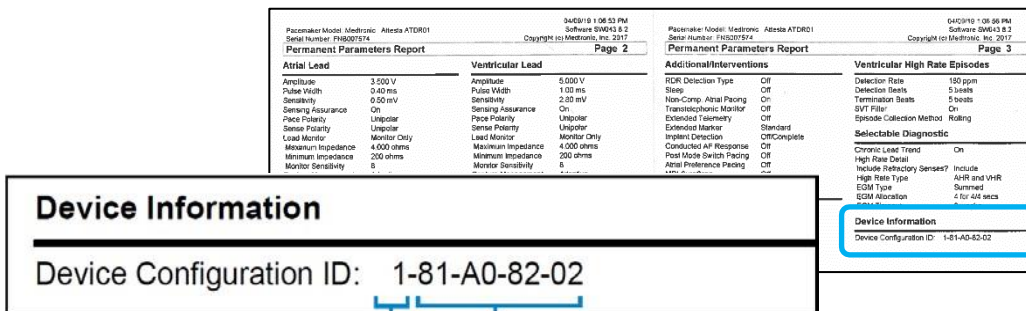
Look for "1-" These values may differ

14. Verify the "Device Configuration ID" at the bottom of the Parameters Report starts with "1-".

If it starts with "1-", the pacemaker has been updated successfully.  
No further action is required.
