**Urgent Field Safety Notice - Cover letter for
EMBLEM™ Subcutaneous Implantable Cardioverter Defibrillators (S-ICDs)
(Models A209 and A219)
EMBLEM™ S-ICD Subcutaneous Electrode (Model 3501)**

Subject: Important Medical Device Advisory Update to August 2019 Advisory – A total subset of approximately 38,350 active EMBLEM™ Subcutaneous Implantable Cardioverter Defibrillators (S-ICDs) (Models A209 and A219) with an elevated likelihood for early replacement (Boston Scientific Field Action Reference: 92400926D-FA)

Subject: Important Medical Device Advisory - EMBLEM™ S-ICD Subcutaneous Electrode (Model 3501) with a potential for electrode body fracture (Boston Scientific Field Action Reference: 92384167-FA).

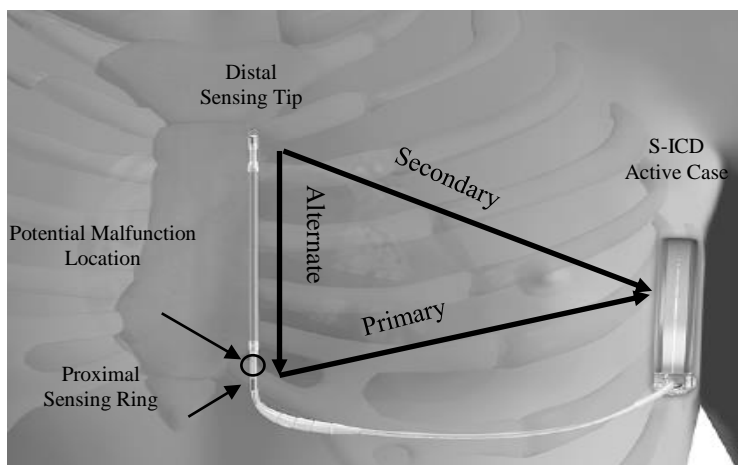
During assembly of the EMBLEM S-ICD Subcutaneous Electrode, a small amount of adhesive is applied to a location just distal to the proximal sense ring. Over time, mechanical stresses on the electrode body at this location may create the potential for a fatigue crack to initiate from the outer lumen. This crack then propagates inward toward the center-oriented distal sense conductor, eventually resulting in a fracture of the two high voltage conductors. To date, Boston Scientific has received 27 reports of electrode body fractures at this location; refer to Figure 1 for an image of the S-ICD system *in vivo*, note the potential fracture location with respect to the programmable sensing configurations (i.e., Primary, Secondary or Alternate).

Figure 1. S-ICD System *in vivo* depicting programmable sensing configurations and the potential malfunction location.

- 7- Replacement. Following consultation with Boston Scientific Technical Services, promptly replace any electrode that is indicated to have compromised integrity as evidenced by non-physiologic, mechanical artifacts, high impedance alert, and/or X-ray. Routine prophylactic replacement of an electrode without evidence of fracture is not recommended. Return explanted devices to Boston Scientific.
