Urgent Field Safety Notice Potential for Shortened RRT-to-EOS

Subset of the following devices:
Claria MRI™/Amplia MRI™/Compia MRI™/Viva™/Brava™ CRT-Ds Visia AF™/Visia AF MRI™/Evera™/Evera MRI™ ICDs

February 2021

Medtronic Reference: FA951

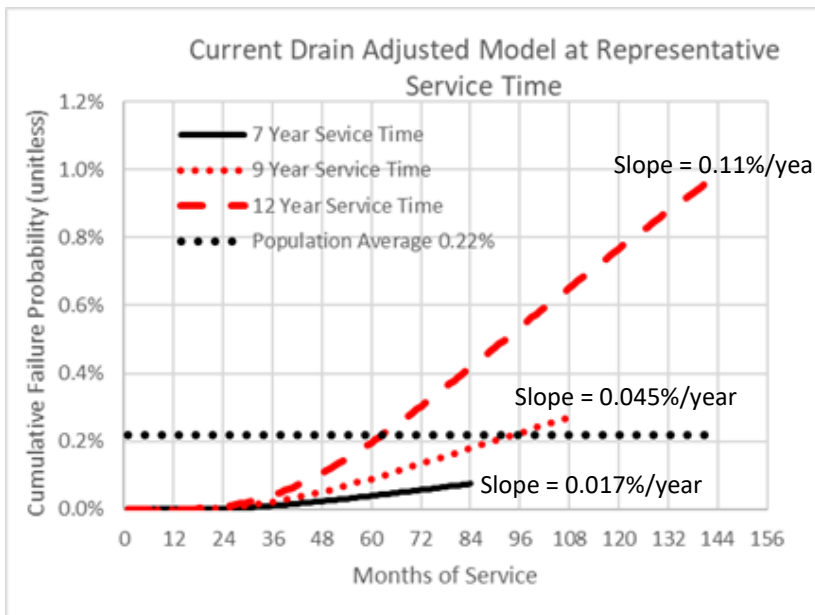
Cumulative Probability is the expected risk for a device to experience this issue between implant and end of service. When risk is evaluated for a device that has reached a service life beyond 3 years, the remaining risk can be estimated based on the yearly risk value shown.

The Population Average (0.22%) is the cumulative probability for the full subset of devices susceptible to this issue. This value takes into account expected longevity and patient mortality. Not all devices with projected service time of 12 years will be in service all 12 years.

Key Points:
Slope of the curve reflects the risk per year based on sample service times of 7, 9, and 12 years.

Slope (risk per year) is constant after approximately 3 years of service time.
