الموضوع: إشعار بمتابعة جهاز طبي مغروس

URGENT SAFETY INFORMATION FOR USERS

Affected products: Augments – CombiCup R® System

Augments of the CombiCup R® System

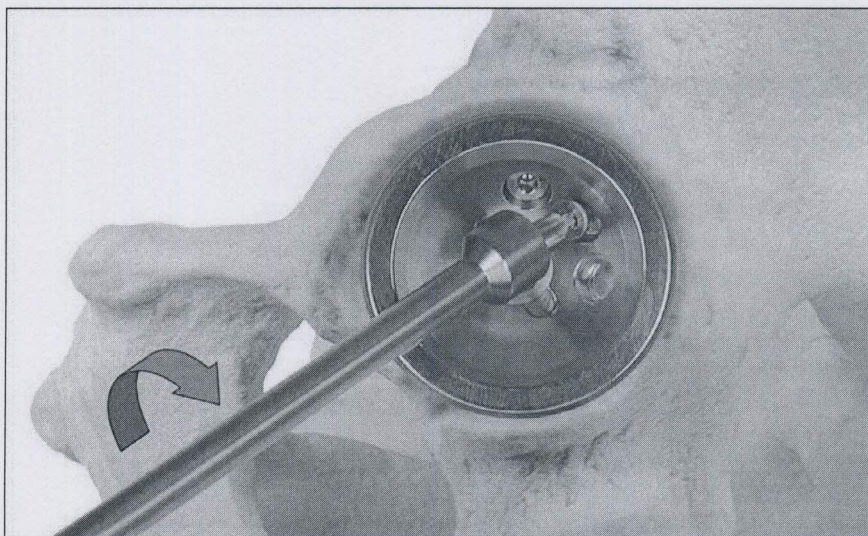
Figure 1, below, shows the action of screwing of the bone screws when implanting the definitive CombiCup R® acetabular cup. The upper screw in the photo is correctly screwed, as it is not protruding inside the cup.

Figure 1: Action of screwing the bone screws to fix the acetabular cup

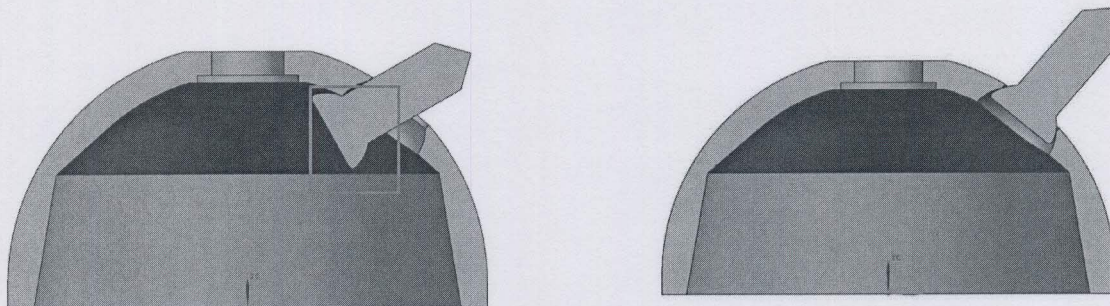
Figure 2, below, further shows the difference between a wrong final position of the bone screw after complete tightening into the cup (left photo, red rectangle), and the correct final position of the bone screw (right photo).

Figure 2: Wrong position (left) and correct position (right) of bone screw

- We kindly ask surgeons to pay particular attention when implanting CombiCup R[®] cups with augments. The intra-operative internal protrusion of bone screws must be absolutely avoided, in order to guarantee a complete conical coupling between the augment and the acetabular cup. Additionally, only for the augments provided with the polar safety screw (figure 5, below), the safety screw must be tightly screwed after inserting the augment into the cup, in order to stabilize the coupling.

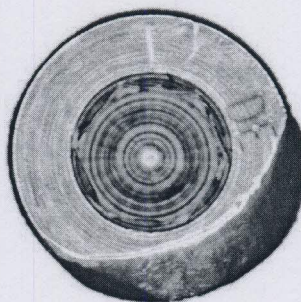
Explanted bone screws, and the analysis on them always showed the presence of metal wear on at least one bone screw head, confirming that the screw head protruded beyond the internal rim of the cup, and became in direct contact with the dome of the augment (see figures 3 and 4, below).

Figure 3: Magnification of explanted bone screw head in case of CombiCup R[®] augment mobilization

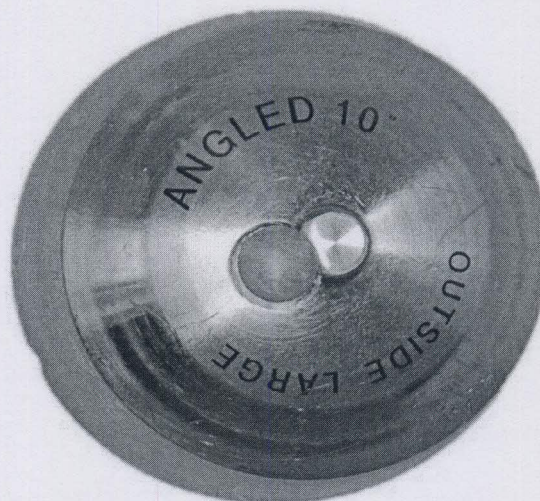
If the protrusion of at least one bone screw occurs during implantation of the augments, this may prevent the complete intra-operative conical coupling between augment and acetabular cup, increasing the risk of future mobilization of the augment.

The effect of such protrusion is proved by a polished circular strip on the dome of the CombiCup R[®] augment (see figure 4, below).

Figure 4: CombiCup R[®] augment mobilized, with metal-metal signs on the dome

- LINK[®] is also updating the Surgical Technique provided with the CombiCup R[®] acetabular System, by introducing a note which advises of the possible incomplete coupling between augment and acetabular cup in case that a bone screw protrudes beyond the internal rim of the CombiCup R[®] cup intra-operatively.

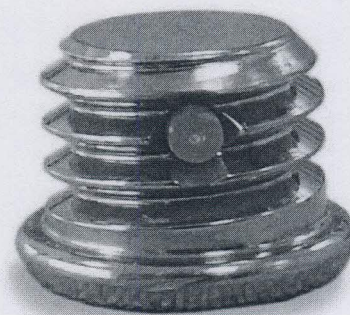
Figure 4: Magnification of polar safety screw provided with the CombiCup R[®] augment
