June 30, 2020

**URGENT: FIELD SAFETY NOTICE – MMS-20-3810**

Alaris™ System PC Unit Model 8000  
Alaris™ System PC Unit Model 8015  
Alaris™ Pump Module Model 8100  
Alaris™ Syringe Module Model 8110  
Alaris™ PCA Module Model 8120  
Alaris™ EtCO2 Module Model 8300  
Alaris™ SpO2 Module Model 8210 and Model 8220

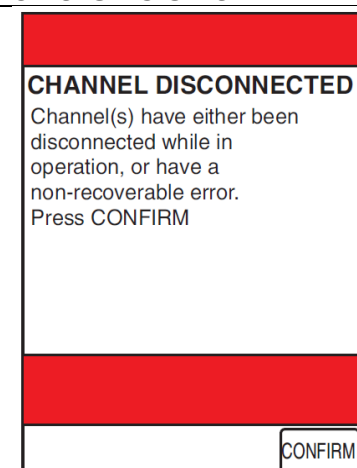
**Figure 1: CHANNEL DISCONNECTED message on the PC Unit**

1. If the BD Alaris™ PC unit loses connection (i.e., power or communication) with its connected modules while the module is in use, a CHANNEL DISCONNECTED message will appear on the PC Unit (Figure 1) and an audio and visual alarm sounds.
2. Two possible scenarios can occur with the affected infusion or monitoring module(s):
  - a. **Loss of power to the PC unit results in power loss of any connected module and the PC unit will alarm. If the module loses power, the infusion or monitoring stops.**
  - b. **If the module loses communication, the module continues to infuse or monitor with a COMMUNICATION ERROR message scrolling on the module (Figure 2).** The module will continue to operate according to the programmed parameters as indicated by the green INFUSE indicator. The red ALARM indicator will flash to alert you to the error.

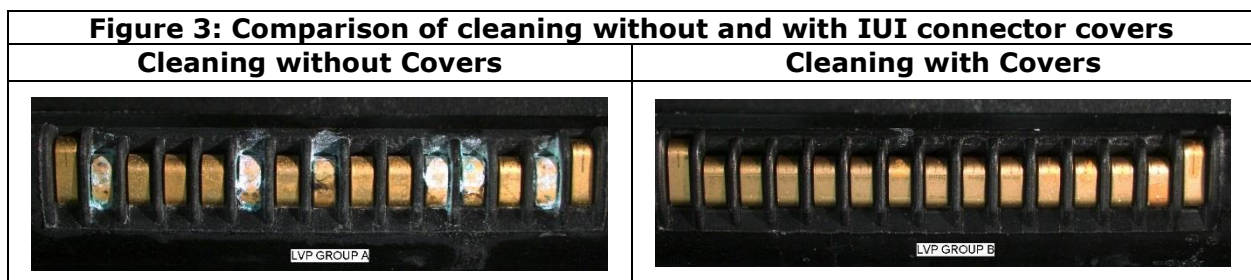
Damage to IUI connectors include cracked or broken pins and the presence of surface contaminants (i.e., blue or green deposits, corrosion, cleaning residue deposition). This damage may be caused by the following:

- Use of cleaning agents other than 70% Isopropyl Alcohol on the IUI connectors;
- Inadvertent exposure to cleaning agents during cleaning of the case; or
- Inadequate drying of the IUI after cleaning.

Per the Alaris™ System User Manual, inspect the IUI connectors on each PC unit and module during the cleaning process. Devices having IUI connectors with any damage, cracks, surface contaminants (i.e., blue or green deposits, corrosion, cleaning residue deposition) (refer to Figure 3), or contact or pin damage on the IUI connectors must be taken out of service and sent to Biomedical Engineering for repair.

**BD is revising the procedure for cleaning the Alaris™ System to include the use of IUI connector covers.** BD will provide existing customers an Alaris™ System Cleaning Kit and an updated Alaris™ System User Manual Addendum from August 2020. The Alaris™ System Cleaning Kit will include IUI connector covers, cleaning brushes to clean the case and IUI connectors, and a quick reference guide. Once received, follow the updated instructions in the User Manual Addendum to clean the Alaris™ System. Failure to use IUI connector covers during cleaning can allow fluids to contact the IUI connectors and damage them over time. Examples of IUI connectors that have been cleaned without IUI connector covers and with IUI connector covers are exhibited below.

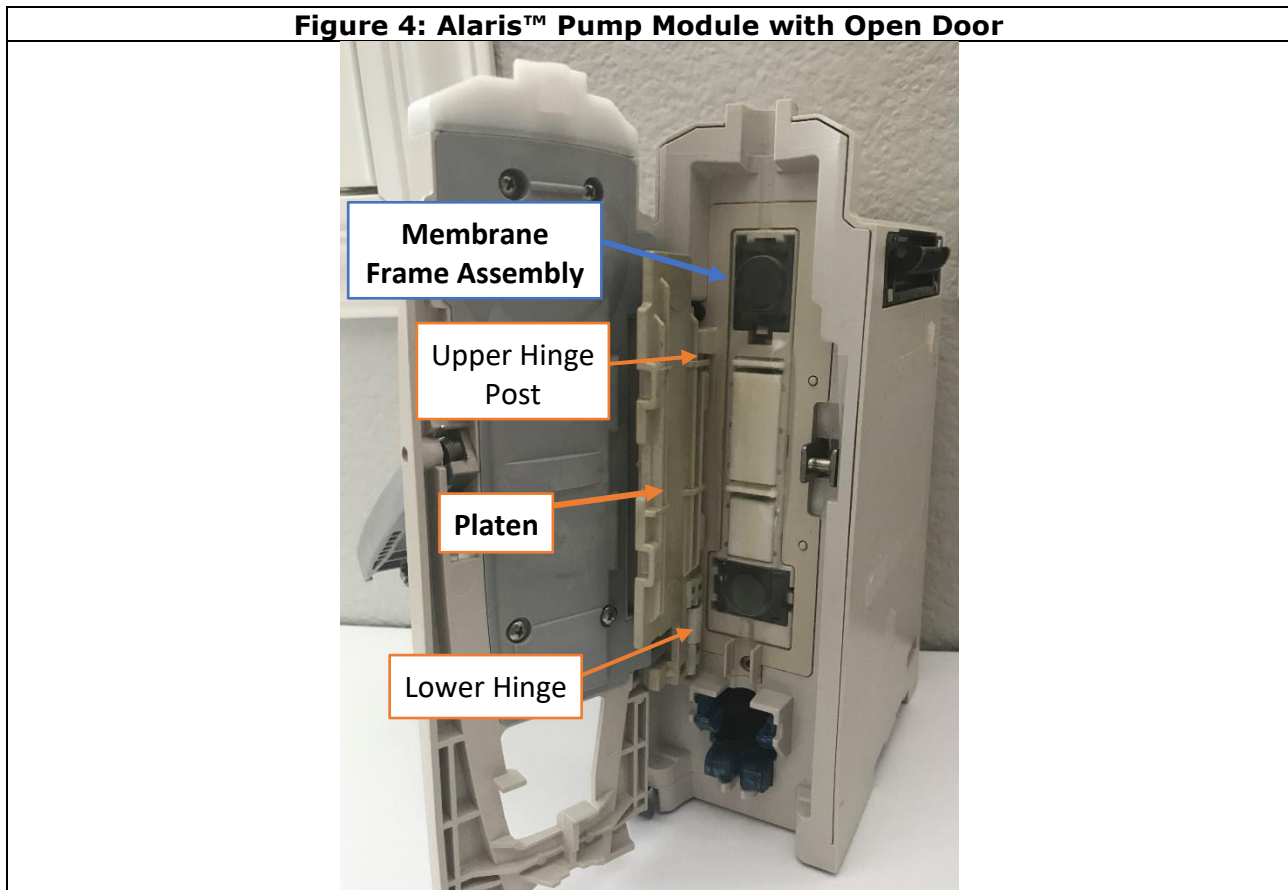
**Figure 4: Alaris™ Pump Module with Open Door**

Based on BD's internal investigation, a broken upper hinge post, lower hinge, and/or membrane frame assembly on the Alaris™ Pump Module platen can occur when the door is forcefully closed on an object (e.g., misloaded IV administration set) or if the device is dropped. Additionally, improper use of cleaners on the membrane frame assembly can lead to cracks on the membrane frame.

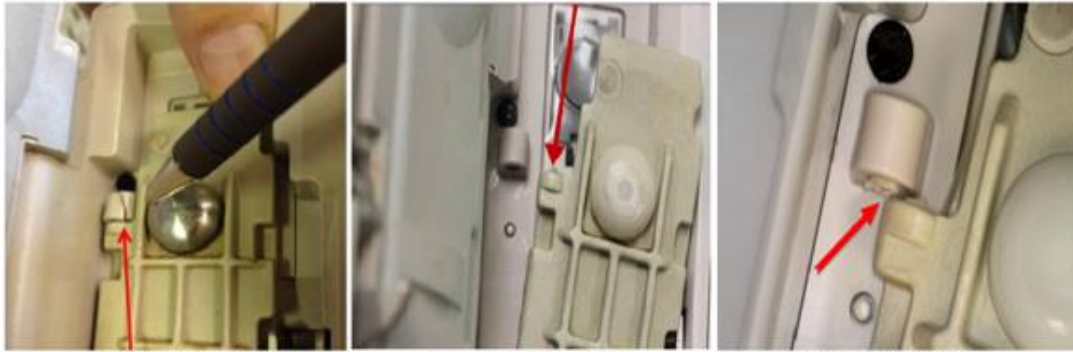
**Figure 5: Broken or Cracked Platen and Membrane Frame**

Expedite inspection of all your Alaris™ Pump Modules for this issue. Verify that the platen upper hinge post, lower hinge, and membrane frame assembly are not broken or cracked (Figure 5). Alaris™ Pump Modules with a broken or cracked platen or membrane frame must not be used. Verify the membrane frame assembly is not loose, and that the seal is not torn. Replace any platen or membrane frame assembly that is broken, cracked or damaged. Follow the instructions in the Technical Service Manual for replacement of platen or membrane frame assembly.

Cracked Hinge on Membrane Frame

Broken Platen Post

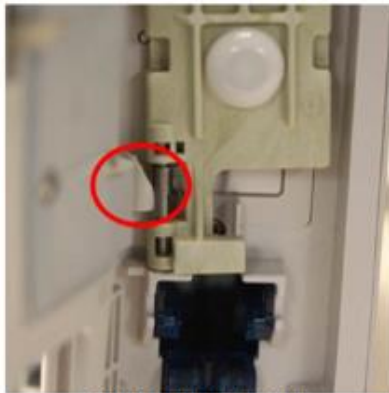
Broken Platen Post

Broken Platen Lower Hinge Bracket

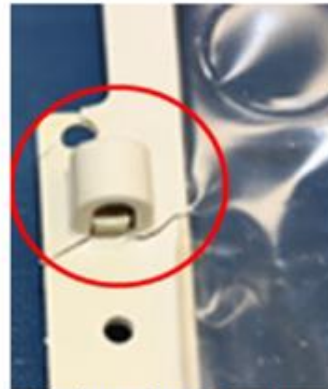
Membrane Frame Breakage

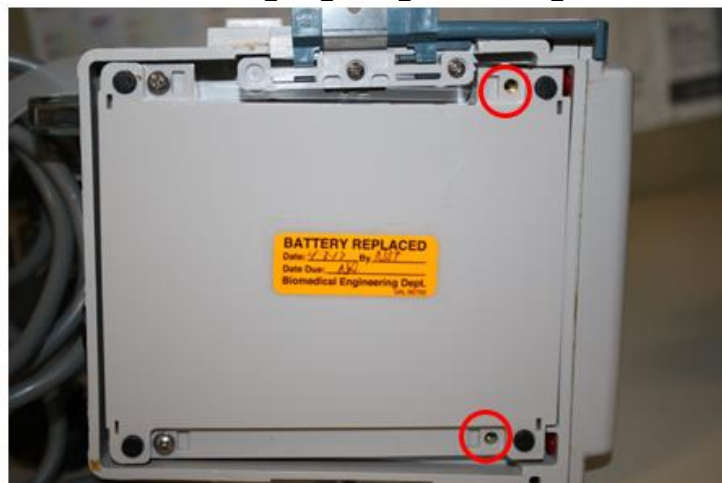
**Figure 5: Bottom of Alaris™ PC unit highlighting 2 missing screws and washers**

If the battery is not properly secured to the Alaris™ PC Unit and is running on battery power, the system may experience a power loss with a prolonged, non-silenceable alarm. There are four screws and four washers that properly secure the battery to the PC unit, and power loss may occur when one or more screws or washers are loose or missing.

Missing or loose battery screws and/or washers that secure the battery to the PC unit may result in power loss to the entire system, including any connected modules, if the device is not plugged into AC power. Power loss may result in an interruption of patient therapy or monitoring when the device is relying solely on battery power. High-risk patient populations who are receiving high-alert IV medications are at the greatest risk of harm. For these high-risk patients, interruptions of therapy can cause serious injury or death.

Expedite the inspection of all Alaris™ PC unit batteries for loose or missing screws and washers. If loose or missing screws and washers are identified, please replace them and torque any loose screws or washers to 6 in/lb and perform battery conditioning. Refer to Service Bulletin 592A for information on battery conditioning.

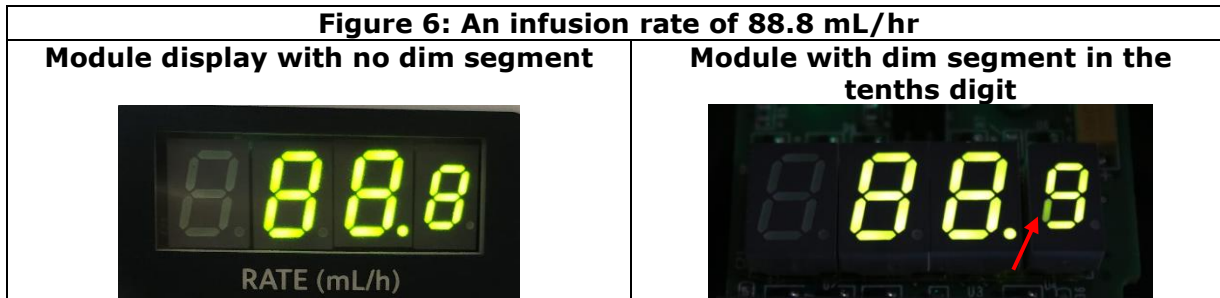
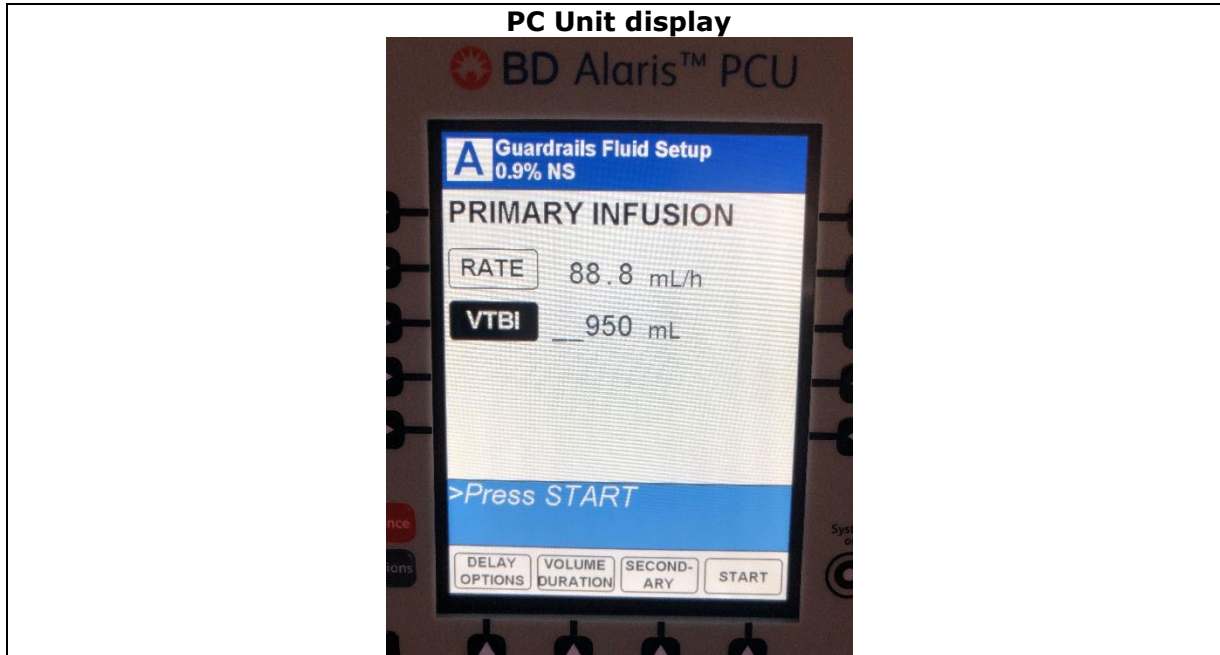
**Figure 6: An infusion rate of 88.8 mL/hr**

The LED display on the module may have some segments that appear dim, and therefore, the number may not be clearly displayed. The programmed infusion parameters can be viewed on the PC Unit display and are not impacted by this issue.

If the Alaris™ module has a dim segment, please contact your local BD representative to order a replacement display board (P/N TC10012952 for LVP Display Board, P/N TC10003525 for Syringe/PCA Display Board, P/N TC10008126 for EtCO2 Display Board, P/N TC10005026 for SpO2 Display Board) at no charge.
