**URGENT: FIELD SAFETY NOTICE – MMS-20-1953**

**BD Alaris™ System PC Unit Model 8000 and 8015**

**Software Upgrade**

**Type of Action: Advisory**

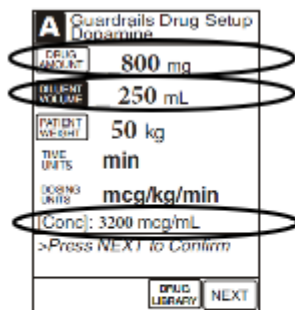
Figure 2. PC unit programming screen  
 Correct Drug Amount is entered  
 Correct Diluent Volume is entered  
 Correct Calculated Concentration is shown

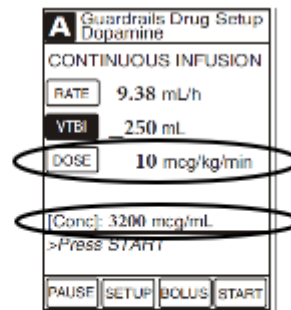
Figure 3. PC unit programming screen  
 Correct Dose is entered  
 Correct Calculated Concentration is shown

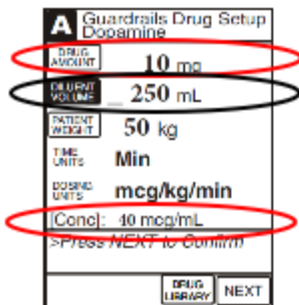
Figure 4. PC unit programming screen  
**INCORRECT** Drug Amount is entered  
 Correct Diluent Volume is entered  
**INCORRECT** Calculated Concentration is shown

Then, when the infusion is started, the calculated concentration results in a calculated concentration being lower than the example medication order. In other words, the clinician has now incorrectly established a dopamine calculated concentration of **40 mcg/mL instead of 3200 mcg/mL** from incorrectly entering dose in the DRUG AMOUNT field. With the intended dose of 10 mcg/kg/min entered, the infusion **will infuse the entire 250 mL bag containing 800 mg** at 750 mL/hour over 20 minutes if no one intervenes.

When programming a custom concentration, clinicians should always review the medication label and program the DRUG AMOUNT and DILUENT VOLUME as indicated on the medication label. After programming the DRUG AMOUNT and DILUENT VOLUME, verify that the calculated concentration displayed at the bottom of the programming screen is correct. Clinicians should always review and confirm infusion parameters before pressing START.
