الموضوع: إشعار بمتابعة جهاز طبي

## FIELD SAFETY NOTICE PRIMARY PLUMSET™ Clave secondary port

<b>Product name:</b>	Administration sets (Infusion pump, Intravenous & Blood transfusion)
<b>List Numbers:</b>	See below.
<b>Lot Numbers:</b>	All – manufactured after July 2007
<b>EMEA FA ID:</b>	Q.FA.EMEA.2013.019
<b>Date:</b>	8 <sup>th</sup> August 2013

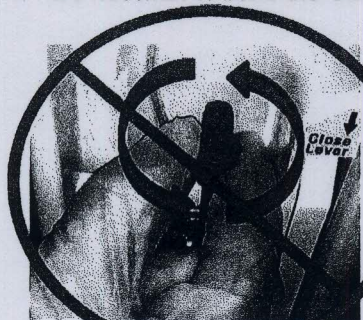
**Do not twist CLAVE**

1. Do not twist or bend the CLAVE when accessing the secondary port.

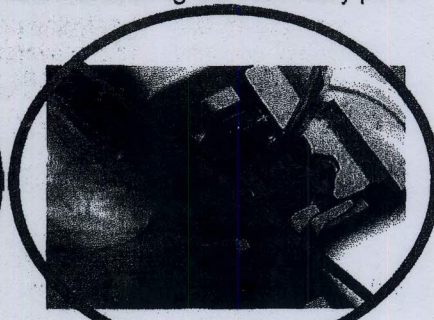
**Do not bend CLAVE**
