FSN 88200484

2015-FEB-12

URGENT – Medical Device Correction
Manual Collimator Exchange system in use with an
ADAC VERTEX Plus, CARDIO, SOLUS or VERTEX V60 imaging system

Collimator cassette may not engage, resulting in potential injury

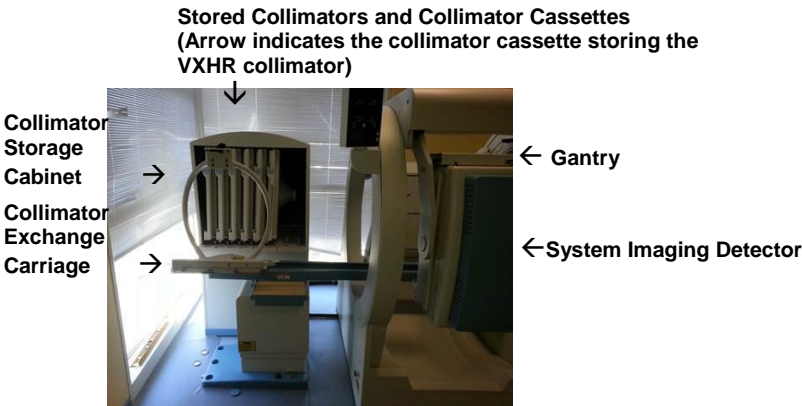
<p style="text-align: center;">Figure 1: Manual Collimator Exchange system</p>

<p>AFFECTED PRODUCTS</p>	<p>Manual Collimator Exchange system in use with an</p> <ul style="list-style-type: none"> • ADAC VERTEX Plus, • ADAC CARDIO, • ADAC SOLUS or • ADAC VERTEX V60 imaging system <p>Refer to the “HOW TO IDENTIFY AFFECTED PRODUCTS” section of this Field Safety Notice for additional information.</p> <p>Please note:</p> <ul style="list-style-type: none"> • Automatic Collimator Exchange system is not affected by this Field Safety Notice. • The affected systems are labeled ADAC Laboratories, not Philips Healthcare.
<p>PROBLEM DESCRIPTION</p>	<p>Philips Healthcare received a report from the field that during a manual collimator exchange procedure, the operator was attempting to slide the collimator cassette containing the detector 2 VERTEX High Resolution (VXHR) collimator from the Collimator Storage Cabinet onto the Collimator Exchange Carriage.</p> <p>As the VXHR Collimator and collimator cassette was being slid onto the carriage, the cassette did not align with the carriage top guide rollers and mechanical lock. The collimator and collimator cassette fell off of the carriage and onto the floor. This resulted in the operator receiving a minor injury. There have been no reports of serious injury as a result of this situation. The Manual Collimator Exchange system and Storage Cabinet are pictured below. Refer to Figure 1.</p> <p style="text-align: center;">Stored Collimators and Collimator Cassettes (Arrow indicates the collimator cassette storing the VXHR collimator)</p>

HAZARD INVOLVED	During a manual collimator exchange procedure a fall of the collimator and/or collimator cassette from the Collimator Exchange Carriage may result in serious injury to a person if it comes in direct contact with the operator and/or the service personnel.
HOW TO IDENTIFY AFFECTED PRODUCTS	<p>Refer to the System Label affixed to the bottom right rear of the gantry cover. The “Description” box identifies a Manual Collimator Exchanger System. Refer to sample label below:</p> <p style="text-align: center;">“SYST, CAM, <u>MAN</u>, EXCH, IVY”</p>

<p style="text-align: center;">Figure 2: System Label</p>
ACTION TO BE TAKEN BY CUSTOMER / USER	<ul style="list-style-type: none"> • If a misalignment on the top and/or bottom of the guide rail between the cabinet and carriage can be visually detected do not continue with the collimator exchange procedure. • If the misalignment is visually detected, be aware that the customer/user cannot remedy this issue and will require service interaction prior to the continued use of the system. • This letter should be placed in your User Documentation until otherwise notified.

ACTIONS PLANNED BY PHILIPS HEALTHCARE	<p>Philips Healthcare is initiating this field correction consisting of:</p> <ul style="list-style-type: none"> • The distribution of a Field Safety Notice 88200484 informing the operator of the issue, and • Conducting the appropriate field correction through a Field Change Order (88200484).
FURTHER INFORMATION AND SUPPORT	If you need any further information or support concerning this issue, please contact your local Philips representative or the UK Philips Customer Care Service Centre on 0870 532 9741.
