Safety Notice – Voluntary Product Recall

MIT-H[®] Offset Cup Impactor

Product	REF / Item number	Lot-No
MIT-H [®] Offset Cup Impactor, angled, for BetaCup [®] and T.O.P. [®] , 410 mm	291-302/30	All lots

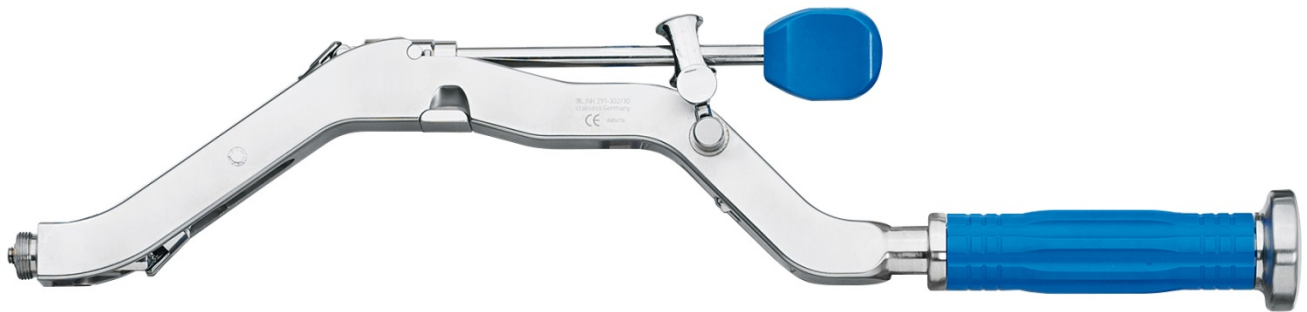
Figure 1: MIT-H[®] offset cup impactor

Figure 1 shows the affected MIT-H[®] Offset Cup Impactor.

The OEM manufacturer “Greatbatch” informed the customers about a Field Safety Corrective Action (see BfArM reference 0694/14) that for the affected MIT-H[®] Offset Cup Impactor, the minimum sterility assurance level (SAL) of 10⁻⁶ cannot be achieved if the instrument is exposed to the steam sterilization cycles and the associated drying times which are specified in their current instructions for use. The cup impactor is supplied non-sterile and must be sterilized prior to use in the surgery.

Based on sterilization parameters (e.g. drying time > 20 min.), which cannot be met in Germany resp. Europe, the sterilization instructions mentioned in the FSCA (see table 1) are not appropriate to address the problem.

Recall of all affected products.

- Should you have any of the affected MIT-H[®] offset cup impactor in your inventory, please send the products back to Waldemar Link GmbH & Co. KG.
- Products affected by this recall are the item numbers (REF 291-302/30, all lot numbers) listed in the reply fax.
