# Urgent Field Safety Notice

Getinge is initiating a field safety correction with regards to Washer-Disinfector of GETINGE Getinge 46-Series (CM302) with PACS 300/350 control.

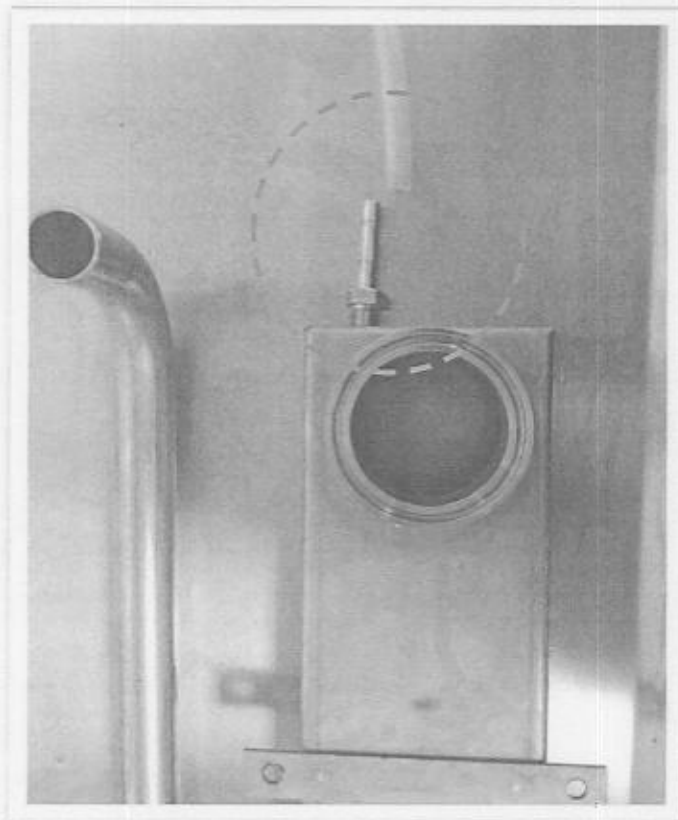
We have however now after performing detailed root cause analysis identified the problem as insufficient water flow throughout the manifold due to formation of air-pockets where sedimentation may occur. Use of detergents that are not recommended might also have negative impact.

Figure 1: vent hole added on top of manifold to prevent trapping of air.

- Cleaning of the manifolds.
- Adding ventilation-hole at the top of the manifold and linking it to the chamber i.e. preventing the formation of any air-pockets and secure a continuous water flow. See details in appendix 1
- Getinge will examine and exchange the check valve twice per year to ensure that there will be no sedimentation.
- In addition during the first 6 months after the corrective measures, monthly visual checks will be carried out by a Getinge service technician or a trained "user-facility" service technician who has received training/instructions from Getinge.
- Getinge will amend the instruction for use regarding the use of detergents, including a list of recommended detergents.

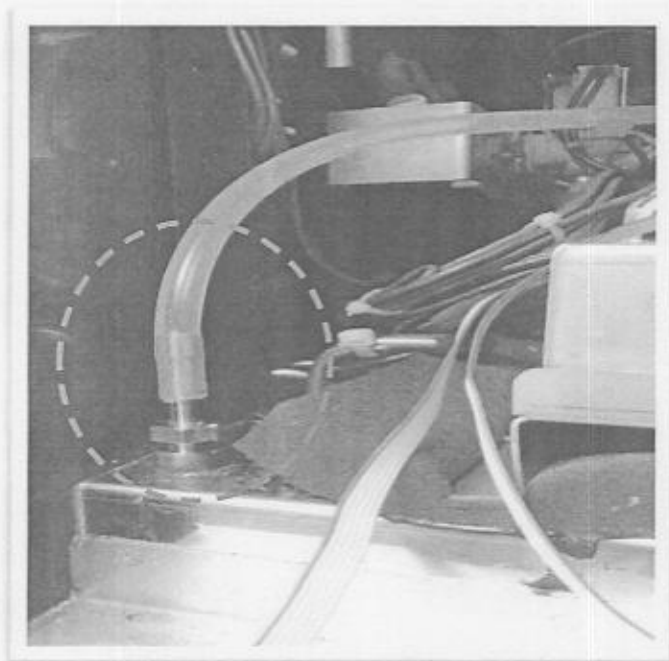
Figure 2: The vent hole is linked back to the chamber through a pipe
