# **Urgent safety information DS-18-01**

## EXCOR<sup>®</sup> blood pumps

Safety information

Date: 28.05.2018

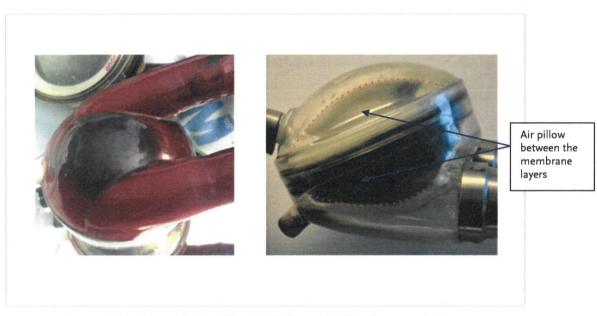
In the more frequent case where there is a disruption of the air side membrane layer, there is a chance that air could get trapped between the air side membrane layer and the middle membrane layer resulting in a pillow of air forming between the two membrane layers and diminished performance of the blood pump. Clinically in this situation it appears that the membranes are not moving or the pump is not filling or emptying completely (see figure 2). The patient may develop symptoms of circulatory insufficiency. It is imperative if this should occur that the blood pump be exchanged per the directions provided in the Instructions for Use by trained medical professionals.

Figure 2: Identifying a defect of the air-side layer: Air pillow between the layers

- 1. Increased attention to the regular control of EXCOR blood pumps. In particular, care must be taken to observe whether an air cushion results in a reduced pumping capacity or if blood is seen in the area around the stabilization ring.
- 2. If there is a suspicion of a membrane defect, the 24/7 Berlin Heart hotline (+49 (0) 30 8187-2772) must be informed immediately and in case of doubt, the EXCOR blood pump immediately exchanged by trained personnel in the clinic.

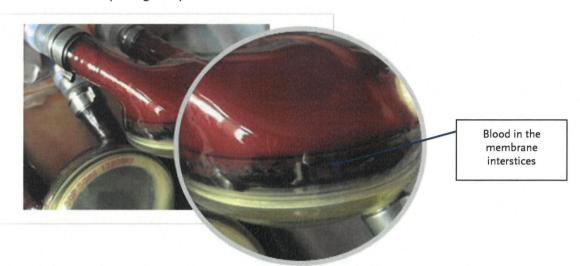
A disruption of the blood side membrane layer is a less frequent occurrence. Most often in this case, blood collects and is visible in a ring around the middle of the blood pump where membranes separate the air and blood chamber (see figure 3).

Figure 3: Identifying a defect of the blood-side layer: Blood in between the membrane layers in front of the stabilization ring.

There are no other clinical findings that have been reported and although this has never been seen, there is also a chance that blood could get trapped between the blood side membrane layer and the middle membrane layer resulting in a pillow of blood forming between the two membrane layers and diminished performance of the blood pump. Clinically in this situation it appears that the membranes are not moving or the pump is not filling or emptying and the patient may develop symptoms of circulatory insufficiency. It is imperative if this should occur that the blood pump be exchanged per the directions provided in the Instructions for Use by trained medical professionals.
