**الموضوع:** إشعار بمتابعة جهاز طبي مغروس

Surgical instruments, implant, Specialist 2 Intramedullary Rod  
(SP2IM Rod)

### **Urgent Field Safety Notice (FSN)**

**Product Name:** DePuy Specialist 2 Intramedullary Rod (SP2 IM Rod)

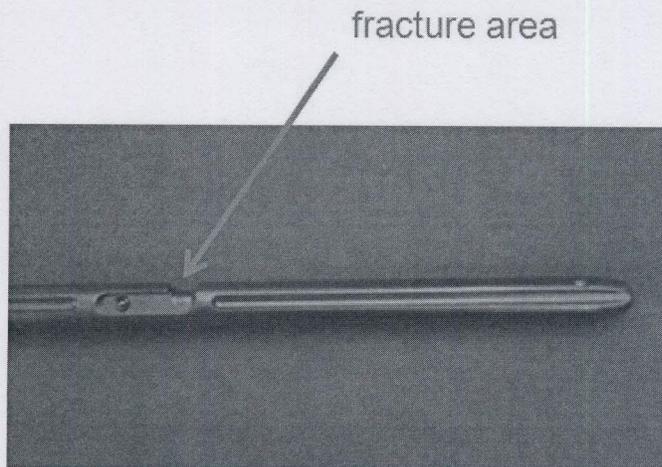
**Attachment B: Photograph of SP2 IM Rod and potential fracture area**

**Background:** DePuy has identified the potential for the SP2 IM Rod to fail due to fatigue when excess leverage is applied at the tip. There is a deep J shaped groove at the tip of the rod, which allows a sleeve to lock into place when used in revision cases (see picture Appendix B). It is at the top of this groove that fracture can occur. DePuy has received 9 complaints since 2008 regarding the tip breaking with 8 complaints where the tip was left in the patient.

DePuy would like to emphasize several technical points regarding the use of the rod that may further reduce the incidence of tip fracture:

1. Avoid using excessive force to drive the rod into the IM canal. If a large amount of force is required to insert the rod, the femoral canal may be overly bowed, or the distal entry hole may be too tight to permit the rod to center in the canal. Should this be encountered, using a shorter IM rod may be more appropriate. Enlarging the distal entry hole may help as well.

2. The rod tip is much stronger when the sleeve slot is in compression. This can be achieved by making sure the slot on the modular handle (the landmark for locking the rod to the handle) is facing medially when the rod is inserted on a right knee, or laterally on a left knee.

3. Do not use the rod as a slap hammer to remove a well-fixed SP2 distal femoral locating device. This can lead to high stress concentrations in the rod tip. If set pins are well-fixed to the distal femur, use a rongeur to release the set pins.

4. The rod should not be used as a femoral distractor to pull the femur away from the tibia. In lieu, use a bone hook or use a U-shaped retractor.
5. Check the condition of the rod on a regular basis. Return any rods showing signs of cracks in the distal tip near the sleeve groove.
