ZIMMER BIOMET

Subject: **URGENT MEDICAL DEVICE FIELD SAFETY NOTICE- CORRECTION**

Reference: **ZFA2018-00039**

Affected Product: Max VPC Tray Base & Max VPC Screw Caddy Brackets

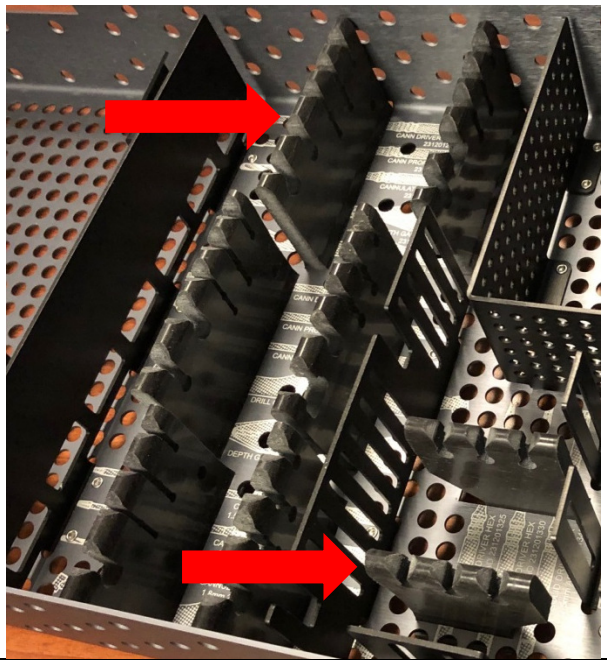
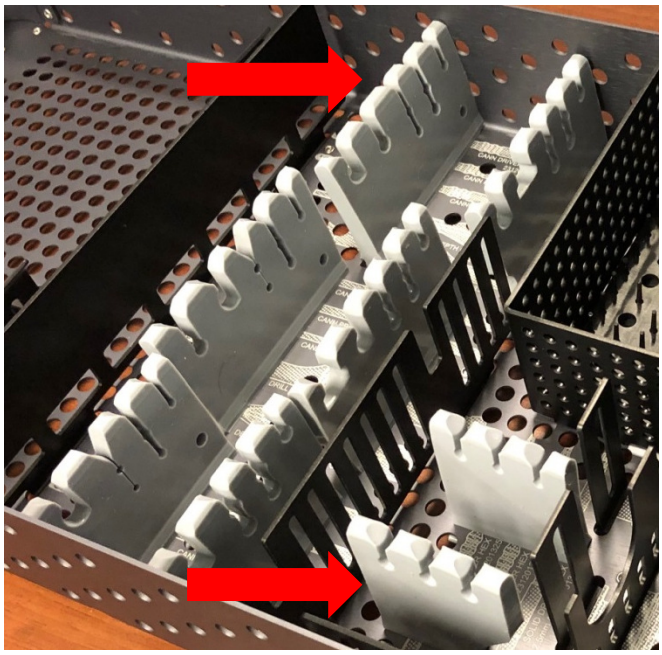
Zimmer Biomet is conducting a lot specific medical device field safety notice/ correction for the Max VPC Tray Base and Max VPC Screw Caddy brackets due to potential silicone shedding during cleaning and sterilization.

Affected Brackets (black), please return to Zimmer Biomet Sales Representative	Replaced Brackets (gray), do not return the product, it is conforming.

This will be a field based correction. A Zimmer Biomet sales representative will retrieve the product from your account. The brackets being corrected are subcomponents of the Max VPC Tray Base and Max VPC screw caddy, and will be replaced with good brackets. Affected units are identifiable by black brackets. Please use the table on page 2 to identify between affected and already replaced brackets.
