Subject: URGENT FIELD SAFETY NOTICE - REMOVAL

FSN/FSCA: FA 2016-03

Affected Product: Zimmer Biomet / Normed Fender Titanium Plates

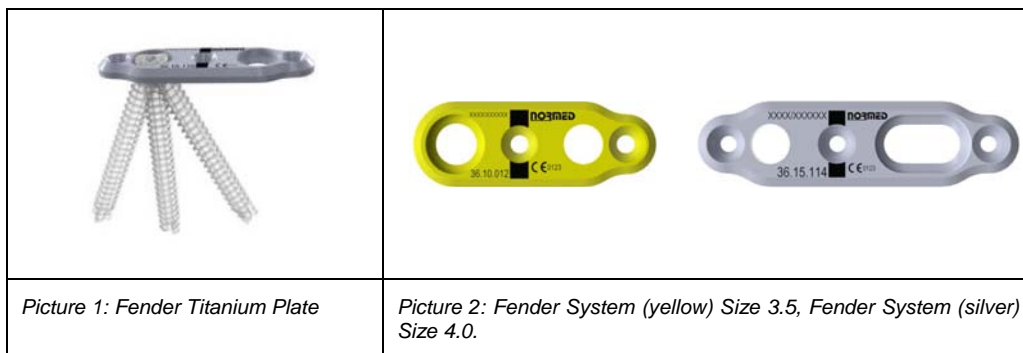
During monitoring of the products a potential risk was recently identified. Indeed the screw head might go through the bore hole of the plate, due to a potential tolerance issue during the manufacturing. If the screw head would slip through the plate's hole, the plate might become loose and the system does not work as intended.

- As the issue might not systematically occur, no preventive removal of the implanted systems is recommended.

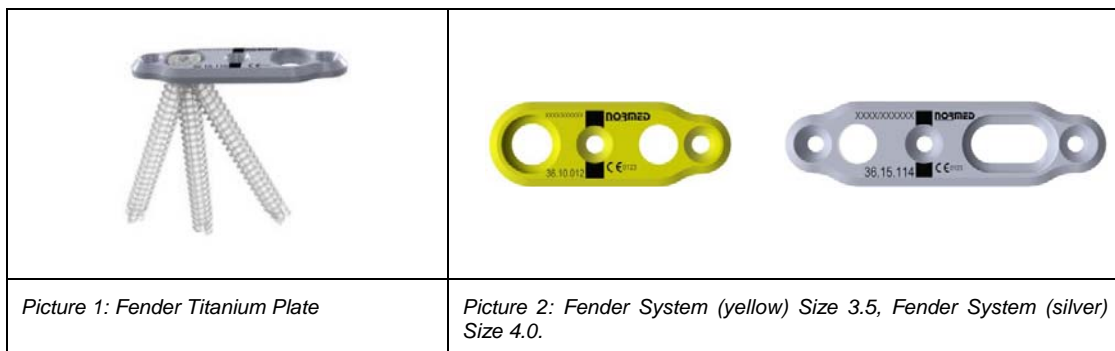
During monitoring of the products a potential risk was recently identified. Indeed the screw head might go through the bore hole of the plate, due to a potential tolerance issue during the manufacturing. If the screw head would slip through the plate's hole, the plate might become loose and the system does not work as intended.

- If an affected product is used, the issue might be noticed intra operatively by the surgeon, and a new available system must be used which creates a potential slight delay in the surgery time.
- For the Fender Titanium Plates already implanted, the standard protocol for follow up of patients (for example X-rays controls) applies. The plates are intended to be removed within short term as soon as the intended correction in the patient is reached.
- If the standard protocol for follow up would show that the screw head went through the hole of the plate, the surgeon must assess the situation and if adequate, the system must be removed with or without replacement. In case of a replacement, the Zimmer Biomet/ Normed system is however currently not available till further notice.
- As the issue might not systematically occur, no preventive removal of the implanted systems is recommended.
